ATM SAFETY AND NIGHTIME LIGHTING SURVEY

3530 S. Main St. Salt Lake City, UT (40.7302,-73.63535)

Exterior · Walkup TTW · Diebold Nixdorf Opteva 562

First Republic Bank ATM Safety & Lighting Survey

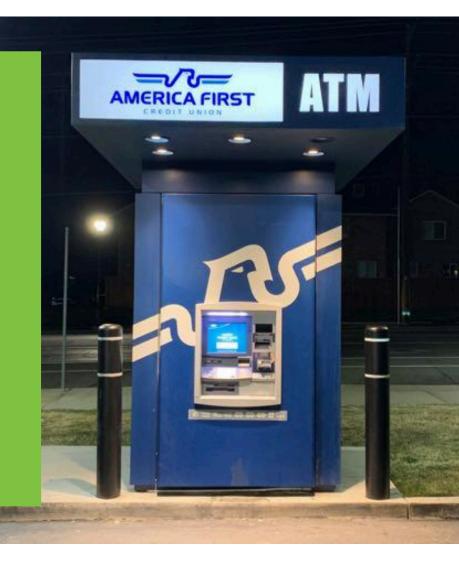
LIGHTING Failed

The illumination at or within five feet of the ATM or ATM entrance is less than 2 foot candles.

The illumination at or within 30 feet of the ATM or ATM entrance is less than 2 foot candles.

The illumination at or within 50 feet of the ATM or ATM entrance is less than 2 foot candles.

Within the parking area the illumination at or within 60 feet of the ATM or ATM entrance is less than 1 foot candles.

Lights Not Working

Item No.	Туре
1	Wall Light

Lights Replacement: None

Reasons Light(s) not replaced Lights Not Replaced as Part of this Survey
