ATM SAFETY AND NIGHTIME LIGHTING SURVEY

3530 S. Main St. Salt Lake City, UT (40.7302,-73.63535)

Exterior · Walkup TTW · Diebold Nixdorf Opteva 562

First Republic Bank ATM Safety & Lighting Survey

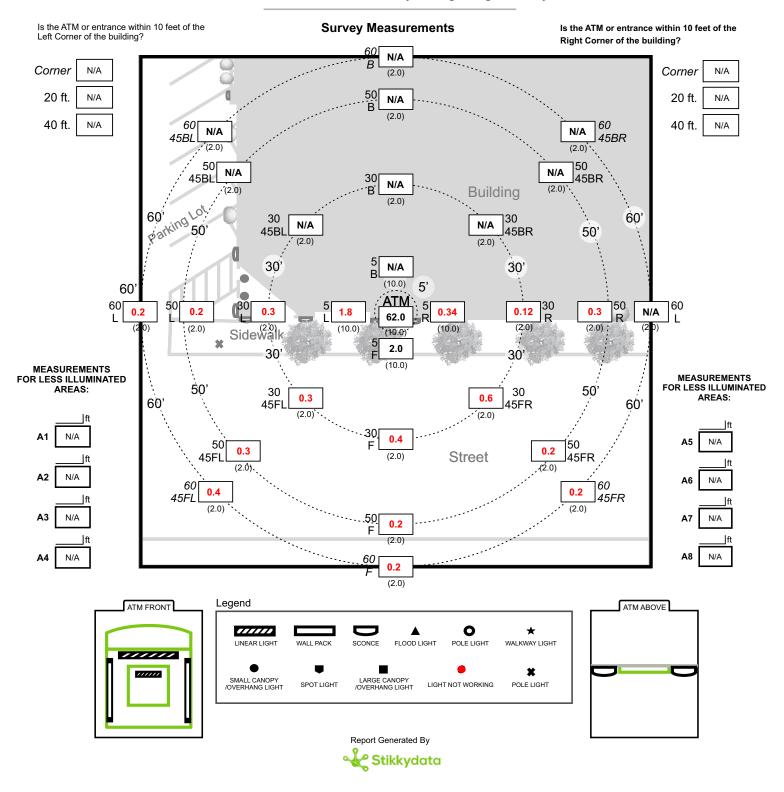
Lighting Diagram

LIGHTING Failed

The illumination at or within five feet of the ATM or ATM entrance is less than 2 foot candles.

The illumination at or within 30 feet of the ATM or ATM entrance is less than 2 foot candles.

The illumination at or within 50 feet of the ATM or ATM entrance is less than 2 foot candles.

Within the parking area the illumination at or within 60 feet of the ATM or ATM entrance is less than 1 foot candles.

Lights Not Working

Item No.	Туре
1	Wall Light

Lights Replacement: None

Reasons Light(s) not replaced Lights Not Replaced as Part of this Survey
